TE10 TABLET ELEVATOR - DESIGN UPGRADES

2021-06-03

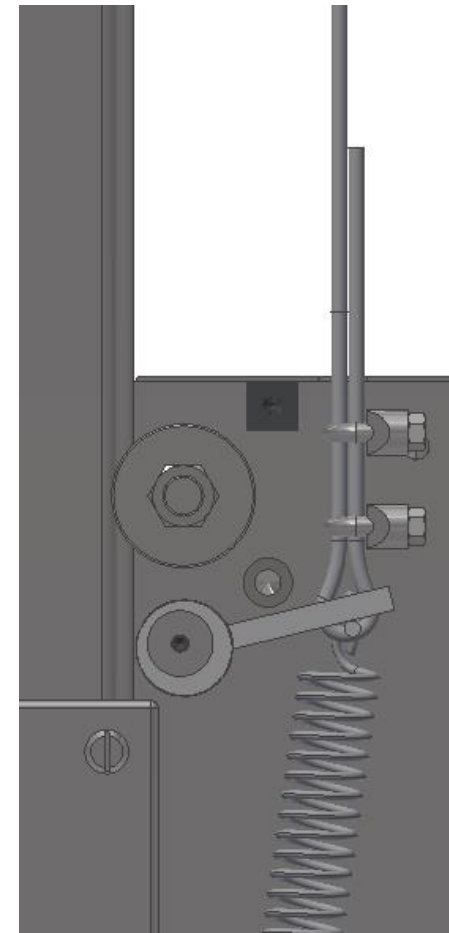
Before

- New attachment method using a cable with a built-in reinforced loop and a shackle
- A new guard and brushes added due to movement of the shackle when brake engages/disengages

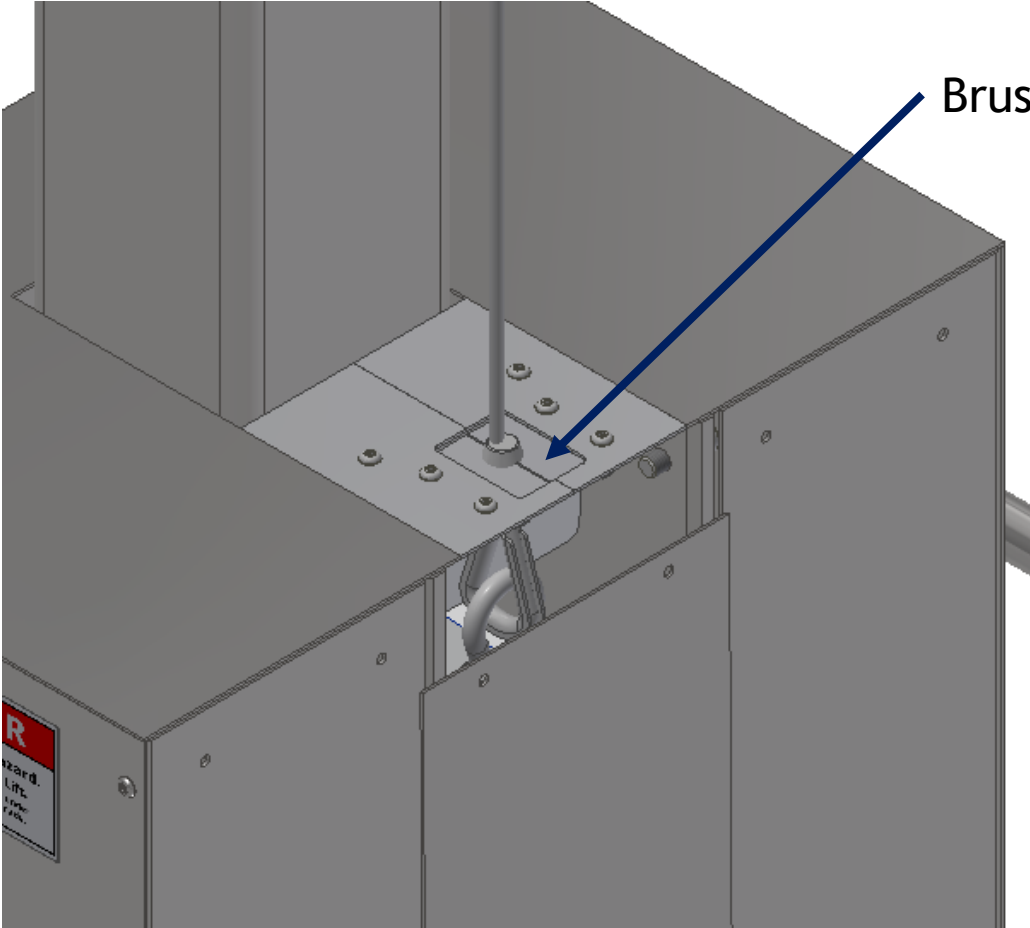
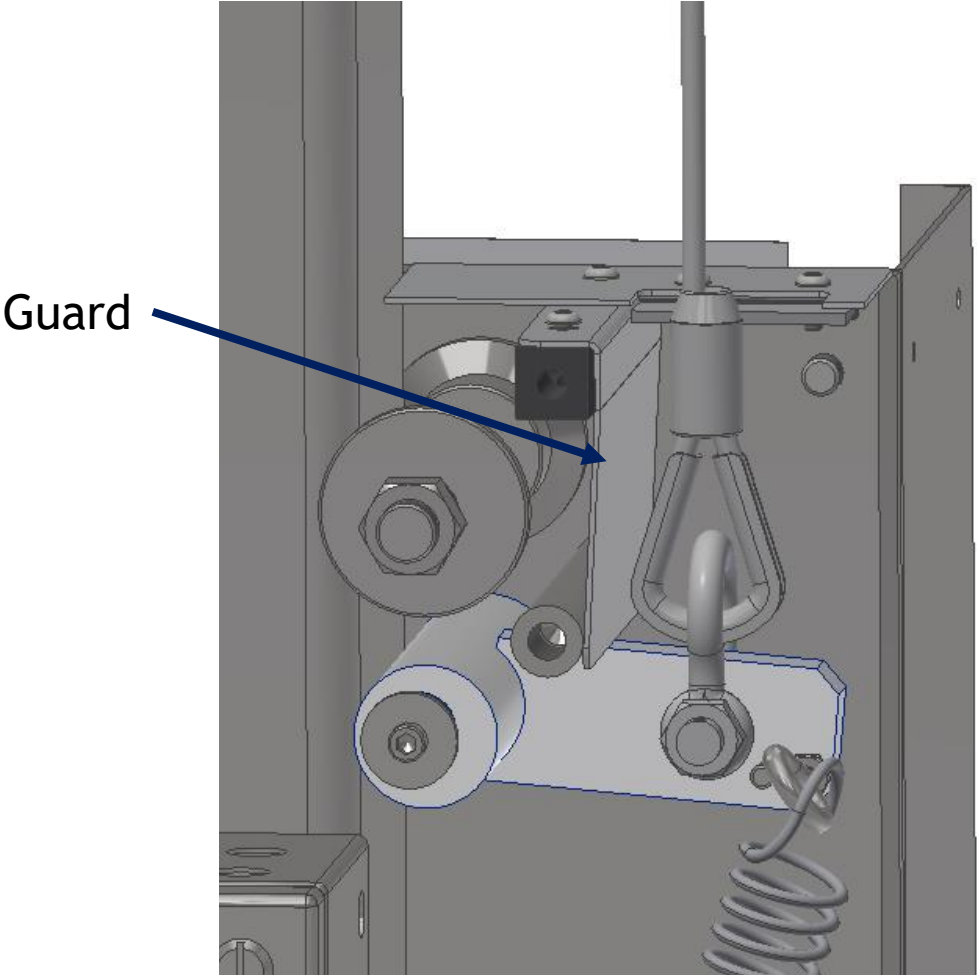
Guard and Brushes

- When brake is engaged, it rotates, causing cable to move laterally
- Guard prevents cable from hitting the square post, preventing wear

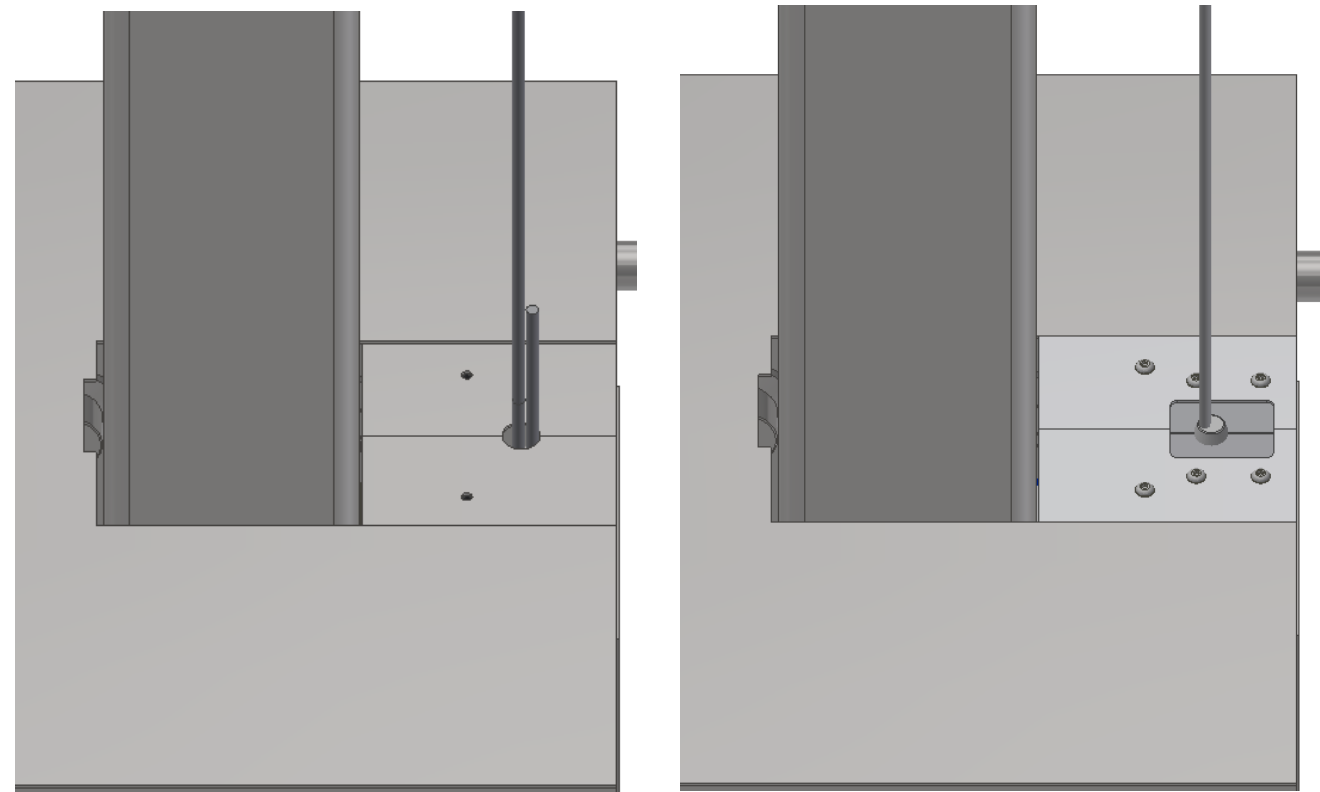
- The previous design included metal sheets with a round hole for the cable. Lateral movement in the cable would cause the cable to rub against this hole
- The brushes allow lateral movement in the cable without wear

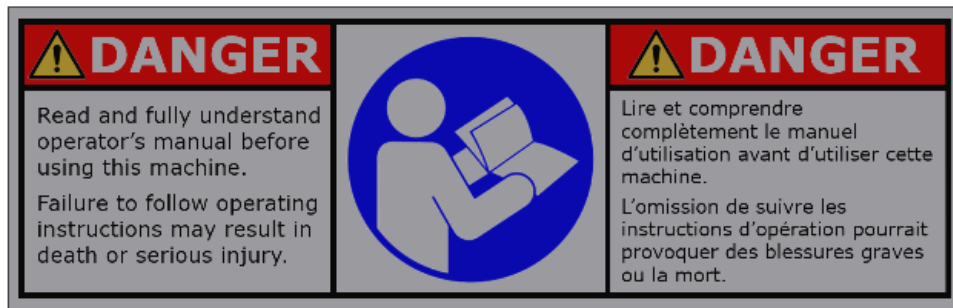
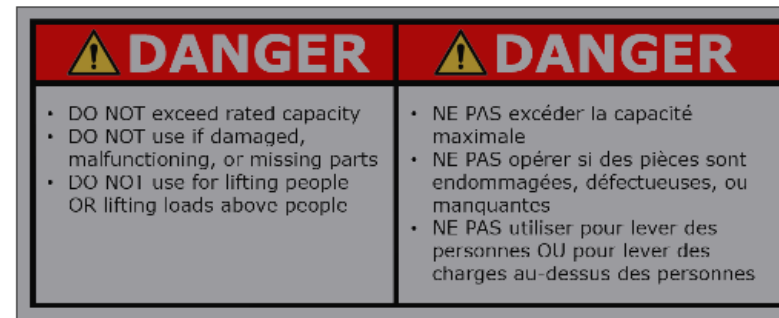
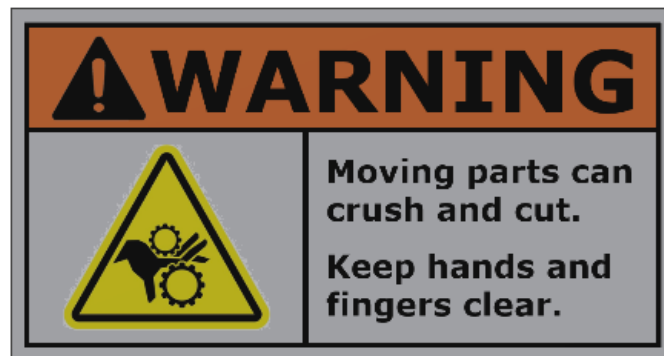
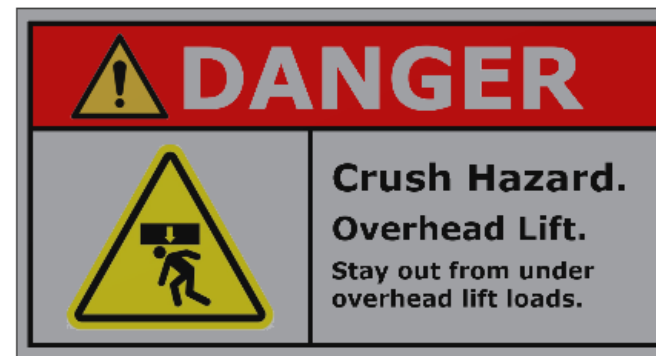
- New safety signs according to the standard: ISO 2864-2: 2004

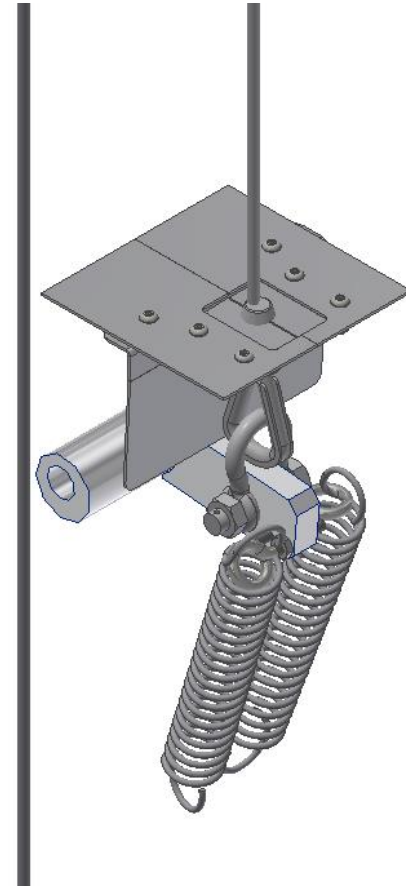
- TE10-AS0007-00 retrofit kit for new brake and cable assembly
 - Refer to assembly drawing for installation instructions
 - Parts included:
 - Brake
 - Brush kit
 - Cable guard
 - Cable
 - Shackle
 - Springs
 - Eye bolt for spring mounting
 - Safety signs

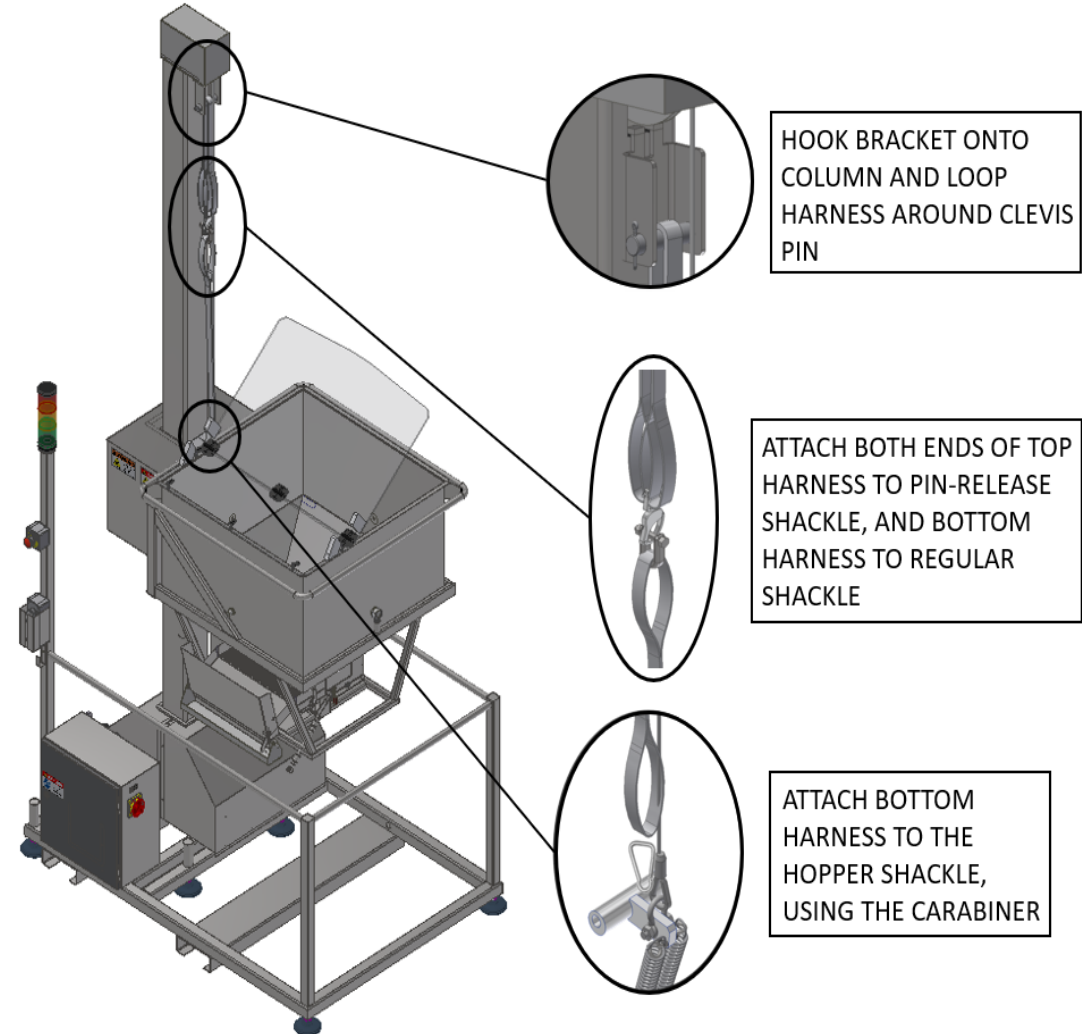
- TE10-AS0009-00 new brake test kit
 - Refer to user manual for full test procedure
